## **ENGINEERING ASSESSMENT OF STRUCTURES AT THE OLD BURYING GROUND STONEHAM, MASSACHUSETTS**

### **STRUCTURES AT THE OLD BURYING GROUND**

## Cemetery Structures Inspection Report

May 25, 2012

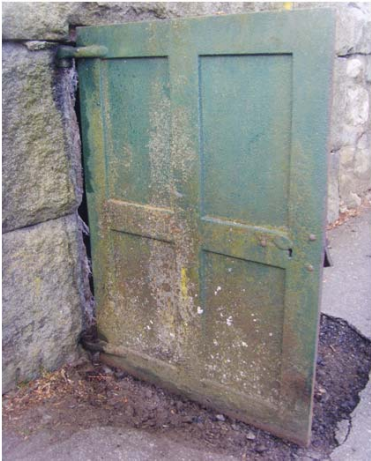
</div> <p>Photo 2</p> <p>Photo 3</p>

<b>Structure</b>	
Town Receiving Tomb (Exterior)	
<b>Inspection Items</b>	<b>Comments</b>
Movement	The front façade is leaning slightly forward. toward the street. See Photo 3.
Door	The hinges are heavily rusted. The door is in fair condition. It has been repainted. The lockset was corroded beyond repair.
Joints	Most of the joints are open to some degree. See Photo 1. The original joints were not mortared. The existing mortar is only partial depth. This was verified from the inside as well. See Photo 3.
Staining	Minor staining and graffiti. See Photo 1.
Plant Growth	Minor Lichen growth See Photo 1.
Overall Condition	Good
Short Term Repairs	Clean Front Exposed Surfaces
Long Term Repairs	Remove and reset front façade Install drainage behind façade stones Restore door and reset Remove jagged stoned on top of headstone

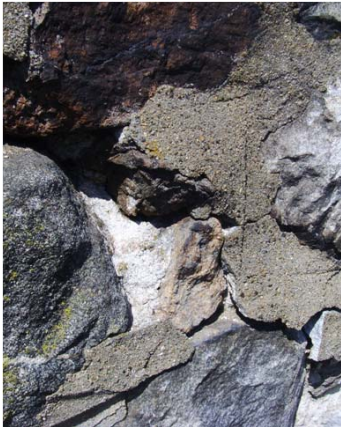
<b>Structure</b>	
Oriental Court Retaining Wall	
<b>Inspection Items</b>	<b>Comments</b>
Movement	Minor if any Most of the wall is very plumb and stable There is a crack near the corner caused by minor movement of the return wall. (just to the right of the "do not enter sign" in photo 1). Photo 3 also shows the crack.
Joints	The return wall near the adjacent building has rough joints with missing mortar. The joints in the main wall are smooth and made with cement based mortar. There is lime based mortar below the cement mortar, which most likely the original mortar. Photo 2 shows the two layers of mortar since the cement mortar has fallen away. Most of the joints are in fair to good condition. Many joints at the base of the wall are missing mortar. This is most likely due to snow plows or water.
Staining	There is staining from the corrosion of the chain link fencing. See Photo 4.
Plant Growth	There is significant plant growth on the fence near the far end. See Photo 1.

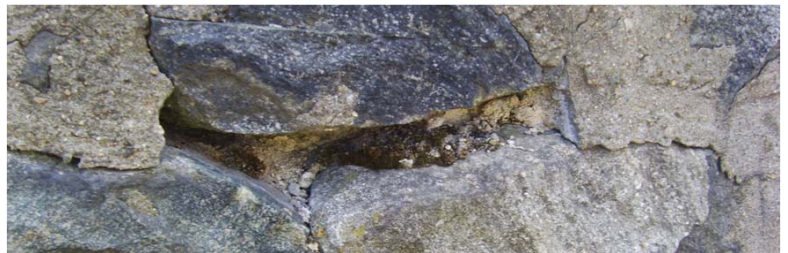
<b>Inspection Items</b>	<b>Comments</b>
Movement	None Most of the wall is very plumb and stable There is a crack near the Oriental Court corner caused by minor movement of the wall.
Joints	The joints are smooth and made with cement based mortar. There is lime based mortar below the cement mortar, which is most likely the original mortar. See Photo 2 shows the two layers of mortar since the cement mortar has fallen away. Most of the joints are in fair to good condition.
Staining	There is staining from the corrosion of the chain link fencing.
Plant Growth	There is significant plant growth on the fence near the far end. See Photo 1. There is minor lichen and moss growth.
Fencing	The jagged stones on top of the wall do not appear to be original. They do not match the details on the Oriental Court wall and the mortar used to adhere the stones is cement based. The fencing is not original (see notes on the Oriental Court Wall). The gate is corroded and damaged, but still functional.
